Exhbit 6

Digital photographs taken by Jay Kalan, City of Murrieta on February 11, 2003 at the Ryland Homes of California, Inc., Serenada site.

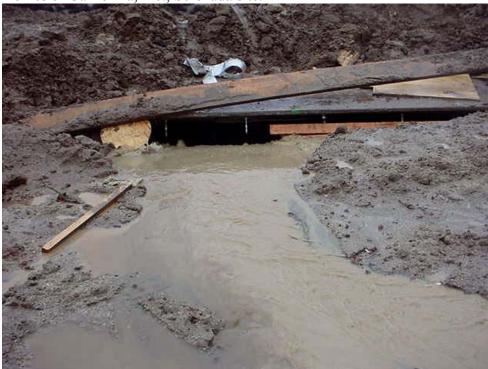
Photograph MVC-023S.JPG taken from Jackson Avenue looks to the east and depicts the discharge of sediment laden water from the Serenada site into the City of Murrieta's storm drain inlet on Jackson Avenue along the Serenada site.

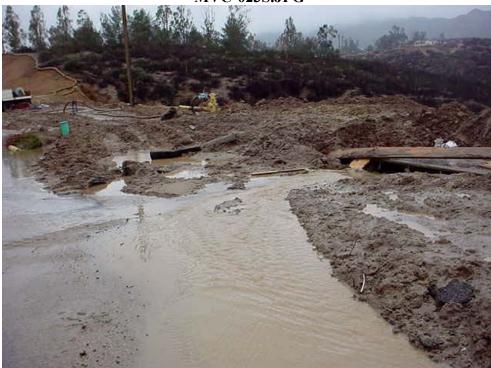
Photograph MVC-024S.JPG taken from Jackson Avenue looks to the northeast depicts the discharge of sediment laden water into the same storm drain shown in MVC023S.JPG.
